RE: Request for Information ("RFI") Pursuant to Section 308 of the Clean Water Act
Preble Hill Farms Concentrated Animal Feeding Operation (NYA000168)
Docket No. CWA-IR-14-025

Water Compliance Inspection Report

Inspection Date: June 19, 2014 Inspection Time: 0805 - 1400	Inspector: Christy Arvizu, Environmental Scientist USEPA Region 2, (212) 637-3961
Weather Conditions: Partly sunny, low 60's to mid 70's	
Inspection Type: Compliance Evaluation Inspection	
On-Site Representatives: David Griswold, Owner, Preble Hill Farms, (607) 423 – 8251; Charles Vogel, employee, Preble Hill Farms, (607) 423 – 5182	
Other Attendees: Ryan Travers, AEM Planner, Agricultural Consulting Services, Inc., (585) 943 - 8556; Jeremy Langner, Service Manager/Agronomist, Agricultural Consulting Services, Inc., (585) 314-8153; Julie Melancon, Environmental Protection Specialist I, NYSDEC Region 7, (315) 426 – 7418	
Preble Hill Farms Site Information:	
Main Farm W Bennett Hollow Road, north of Preble Road Preble, NY 13141	Jack's Farm Intersection of W Bennett Hollow Road and Preble Road Preble, NY 13141
Blooms' Farm 2301 State Route 80 LaFayette, NY 13084	Kuss' Farm Tully Farms Road, south of Otisco Road LaFay

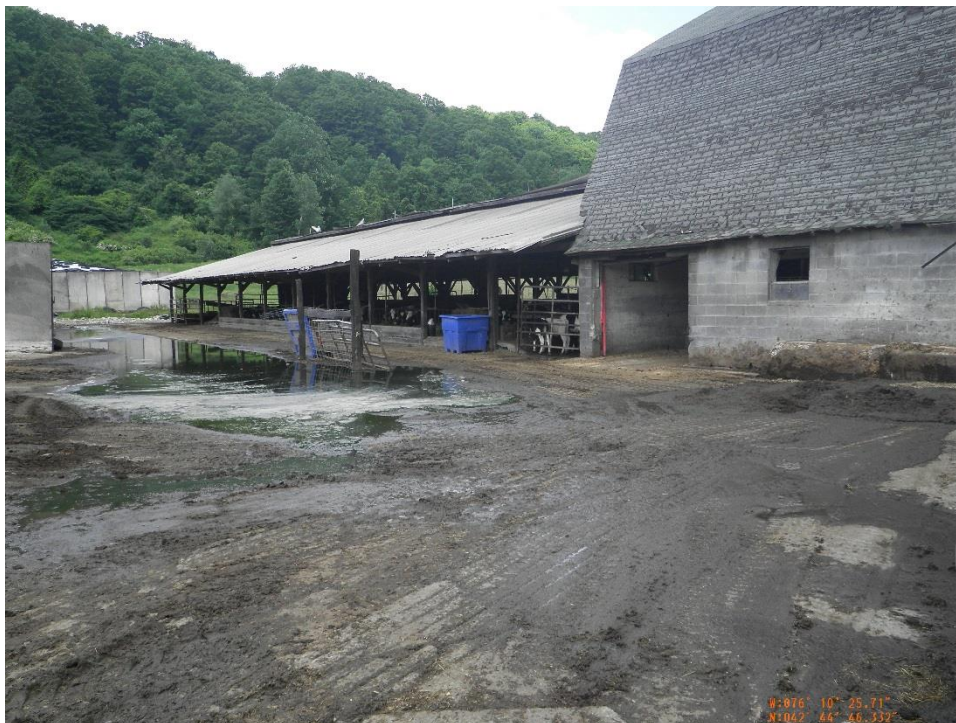
During the inspection, EPA Inspector Arvizu observed dirty pooling water adjacent to (and south of) the Heifer Barn. Mr. Vogel stated that stormwater in this area flows to a tile line to the north of the bunk silo which then outlets to a Vegetated Treatment Area on the south side of the bunk silo. The pooling water was black and contaminated with runoff from the bunk silo, Heifer Barn and Calf Barn. In addition to the pooling water adjacent to the Heifer Barn, EPA Inspector Arvizu observed semi-solid manure stored outside adjacent to the Calf Barn. Mr. Vogel stated that the manure was cleaned up on a daily basis. Mr. Vogel stated that the Facility planned to move calves to a new freestall barn that was to be constructed later in the summer.

Photo #1 – Ponded runoff adjacent to (and south of) the Heifer Barn, also note manure on concrete pad adjacent to Calf Barn in right of frame; view looking west

- a. Heifer Barn at Main Farm – EPA Inspector Arvizu observed dirty pooling water adjacent to the barn and flowing to a tile line to the north of the bunk silo and eventually out to the VTA on the south side of the bunk silo. The pooling water was black and contaminated with runoff from the bunk silo, Heifer Barn, and Calf Barn.

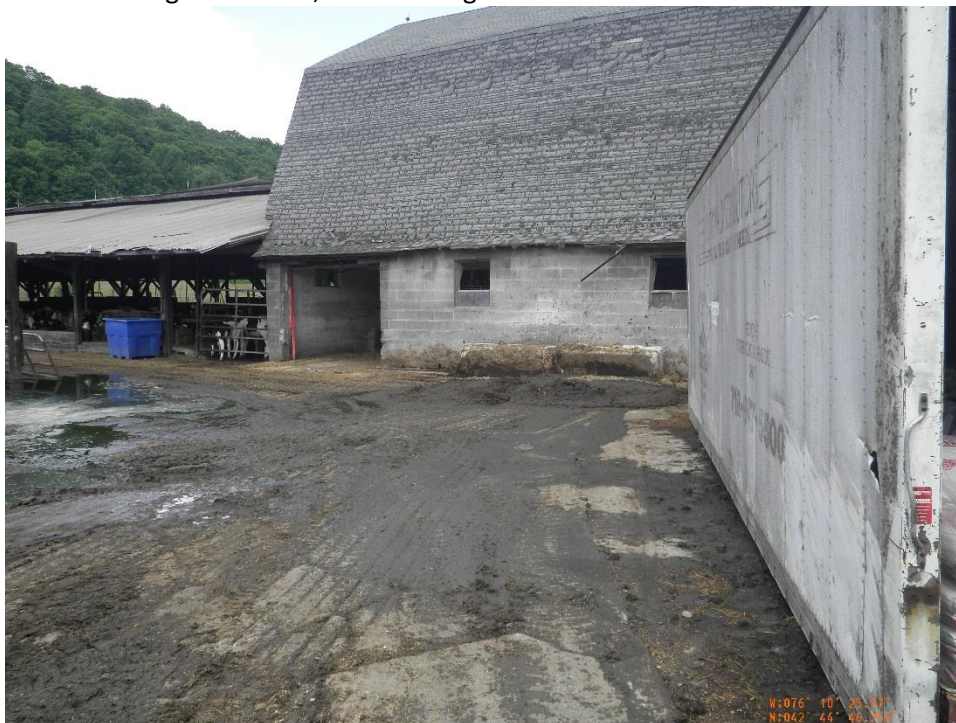
Photo #2 – Manure to the south of the Calf Barn; view looking north

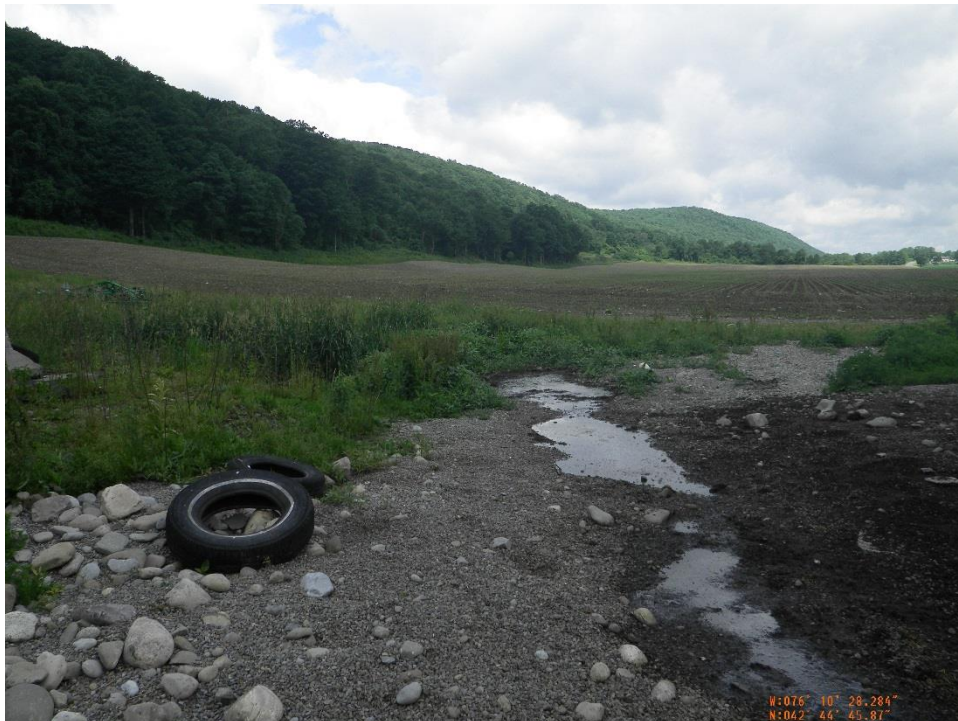
Photo #3 – Flow path from ponded runoff noted in Photo #1 to tile line behind bunk silo; view looking northwest

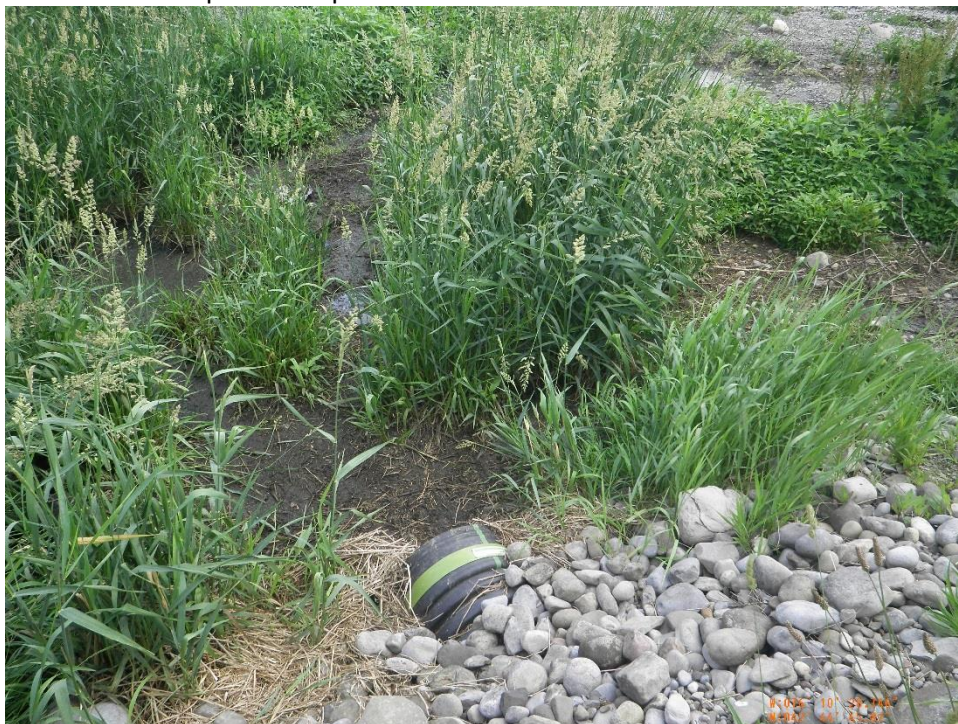
Photo #4 – Inlet pipe to tile line on north side of bunk silo that receives overland flow and contaminated stormwater flow noted in Photos #1 and 3

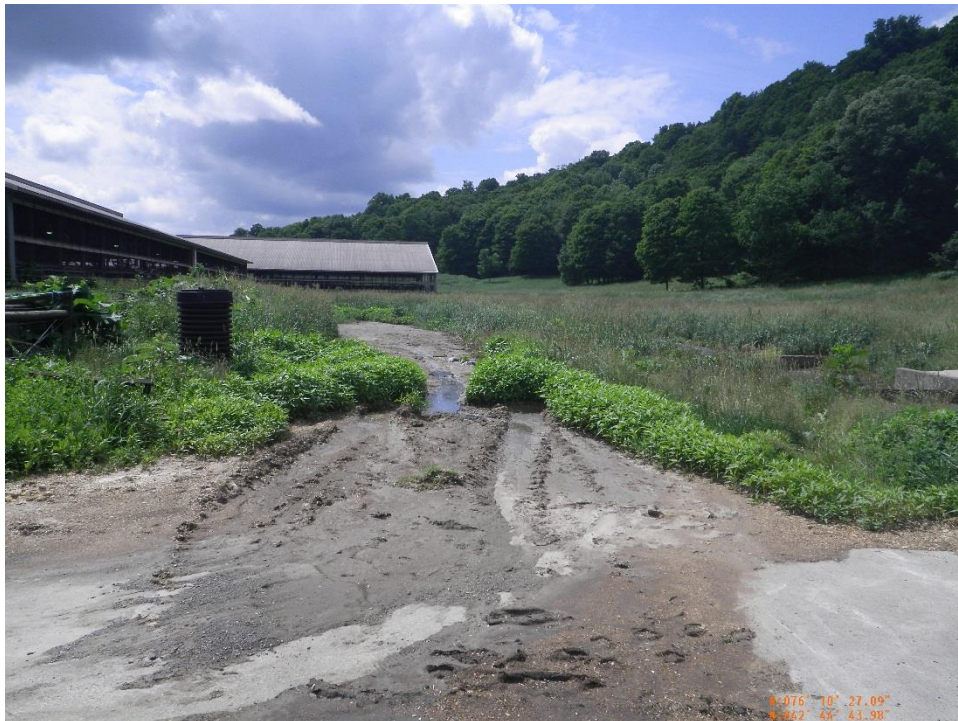
EPA Inspector Arvizu also noted ponding of stormwater and contaminated runoff adjacent to the Facility's silage leachate collection system to the south of the bunk silo. Specifically, ponding was occurring south of the concrete pad near the Facility's settling basin and high flow distribution system. Mr. Travers and Mr. Vogel both stated that Mr. Griswold planned to install concrete in the driveway area to cut down on runoff and allow for easier clean-up. Mr. Vogel stated that the Facility tries to get into the area to clean out solids that collect, but has not been able to do so because it has been too wet.

Photo #5 – Ponding of bunk silo runoff adjacent to leachate collection system; view looking southeast

- c. Bunk Silo – EPA Inspector Arvizu observed ponding of stormwater and contaminated runoff adjacent to the silage leachate collection system at the Main Farm. Specifically, ponding was occurring south of the concrete pad near the Facility's settling basin and high flow distribution system.

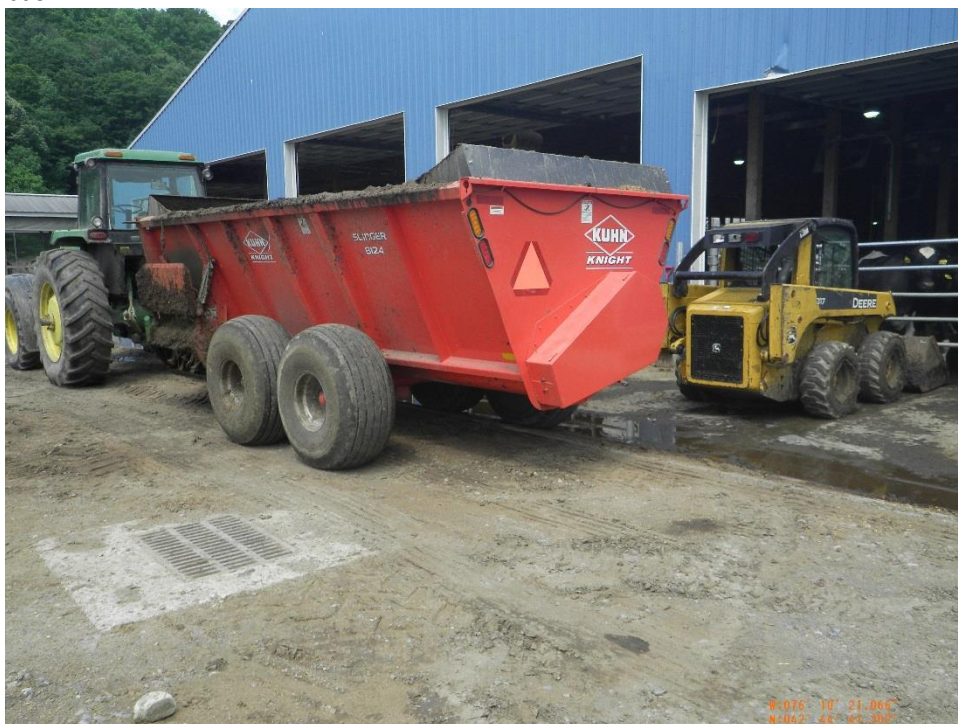
EPA Inspector Arvizu observed a stormwater catch basin at the south end of the Dry Cow Barn that was not identified on the Facility maps. Mr. Vogel stated that the catch basin discharged to a ditch. In the proximity of the general area of the catch basin, EPA Inspector Arvizu observed contaminated runoff from the Dry Cow Barn and loading and unloading operations. However, at the time of the inspection, runoff was not observed to be flowing into the catch basin.

Photo #6 – Catch basin at south end of Dry Cow Barn that outlets to ditch; note ponding of contaminated runoff and manure spreader and skid steer located to the right of the catch basin.

3. During the inspection, the EPA inspection team observed that not all stormwater collection and clean water diversions were mapped on the Facility maps. Specifically, EPA Inspector Arvizu observed a catch basin at the south end of the Dry Cow Barn that was not identified on the farmstead map. In addition, a small drain/inlet was observed at Blooms' Farm adjacent to the high moisture corn silo.

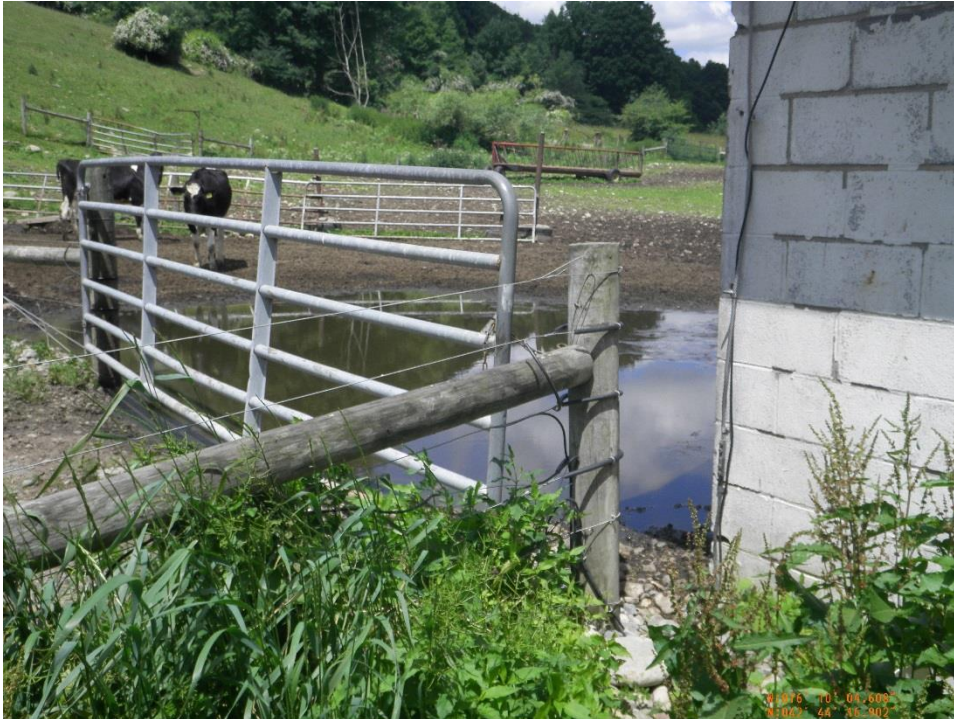
During the inspection, EPA Inspector Arvizu observed ponding water in the southeast corner of the Tiestall barnyard. Runoff from the barnyard could flow down the driveway toward a depressed area that leads to a field.

Photo #7 – ponded water at southeast corner of barnyard at Tiestall Barn

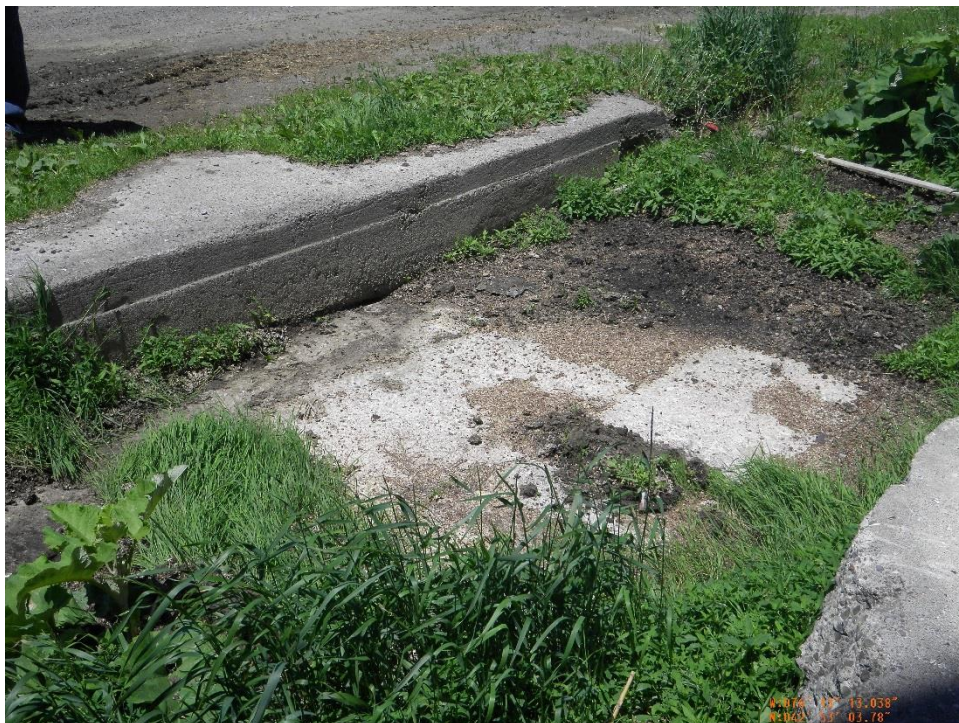
EPA Inspector Arvizu observed a small drain/inlet adjacent to the high moisture corn silo. Feed residue was observed in the area in and around the drain. Mr. Vogel stated that he did not know where the inlet discharged, but believed that it may discharge to the Vegetated Treatment Area to the west of the freestall barn.

Photo #8 – Drain/inlet adjacent to high moisture corn silo, note residue on concrete pad immediately surrounding the drain; view looking west

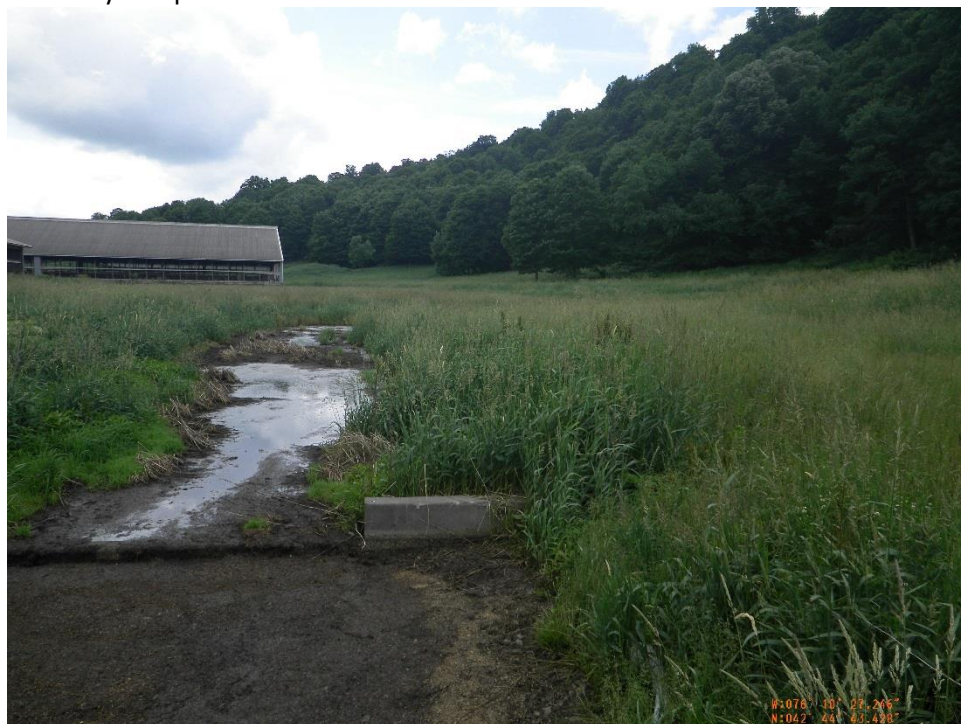
- Excess solids in the collection system (an issue that was noted in the Facility's previous inspection conducted by NYSDEC on 8/27/2013).
- Overgrown vegetation in the VTA. Mr. Vogel stated that the VTA was last mowed during the fall of 2013.
- Significant kill zone observed in the VTA.
- Significant ponding and kill zone observed in VTA south of underbunk drainage which flows to on-site farm pond. Mr. Griswold stated that the farm pond was created as a result of a diversion that was constructed years prior.

Photo #9 – excessive solids build-up & kill zone at High Flow VTA at Main Farm; view looking south

- a. Improper operation and maintenance of the leachate collection system in use at the Main Farm. Specifically, EPA Inspector Arvizu observed excessive solids in the collection system which had been previously noted by NYSDEC during its 8/27/2013 inspection.
- b. In addition, EPA Inspector Arvizu observed that the VTA had not been mowed since fall 2013 as it was very overgrown.
- c. Significant kill zones in the VTA treating silage leachate and underbunk drainage.
- d. Improper operation and maintenance of the collection system in use at Kuss' Farm. Specifically, EPA Inspector Arvizu observed that the collection screens were clogged with residue feed and solids and had not been cleaned out.

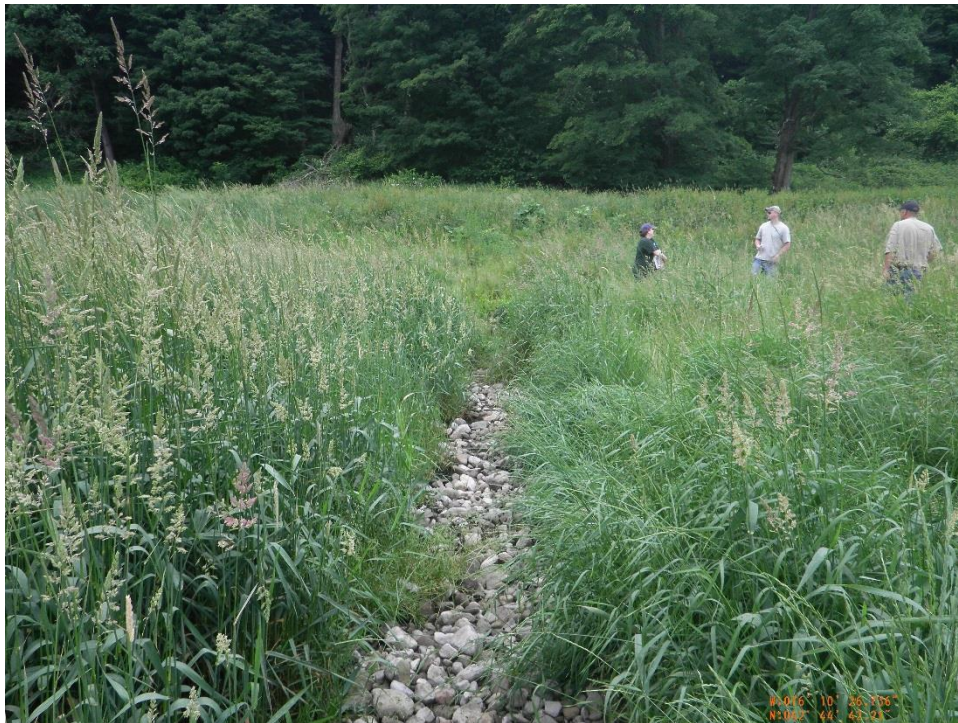
Photo #10 – Overgrown vegetation at VTA at Main Farm; view looking west

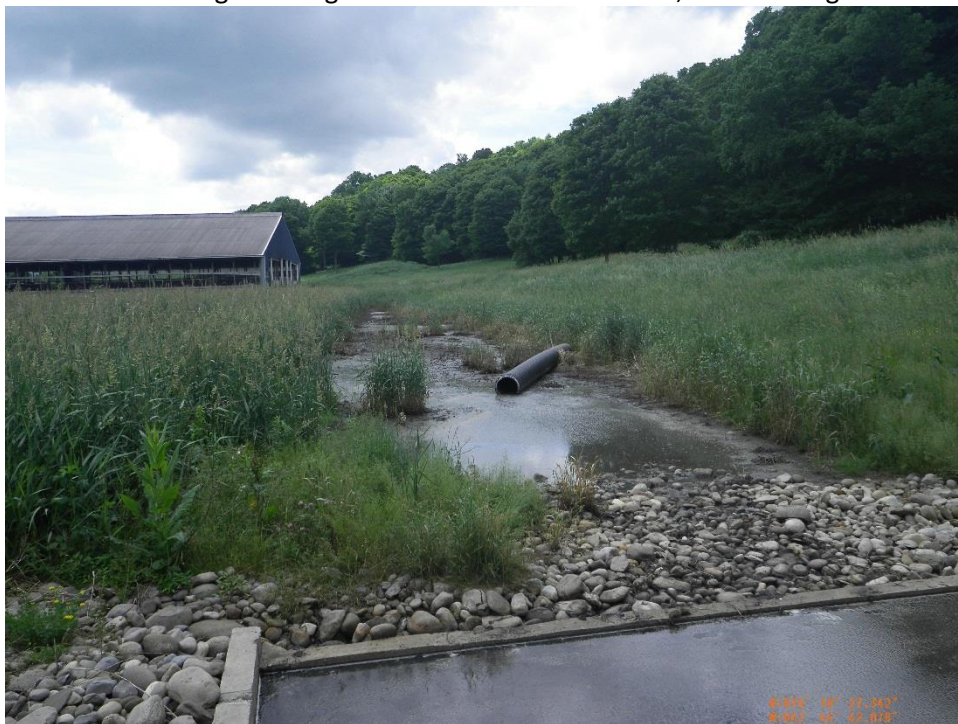
Photo #11 – Excessive ponding south of underbunk drainage at Main Farm; note – this is where contaminated stormwater noted in photos #1, 3 & 4 discharges into

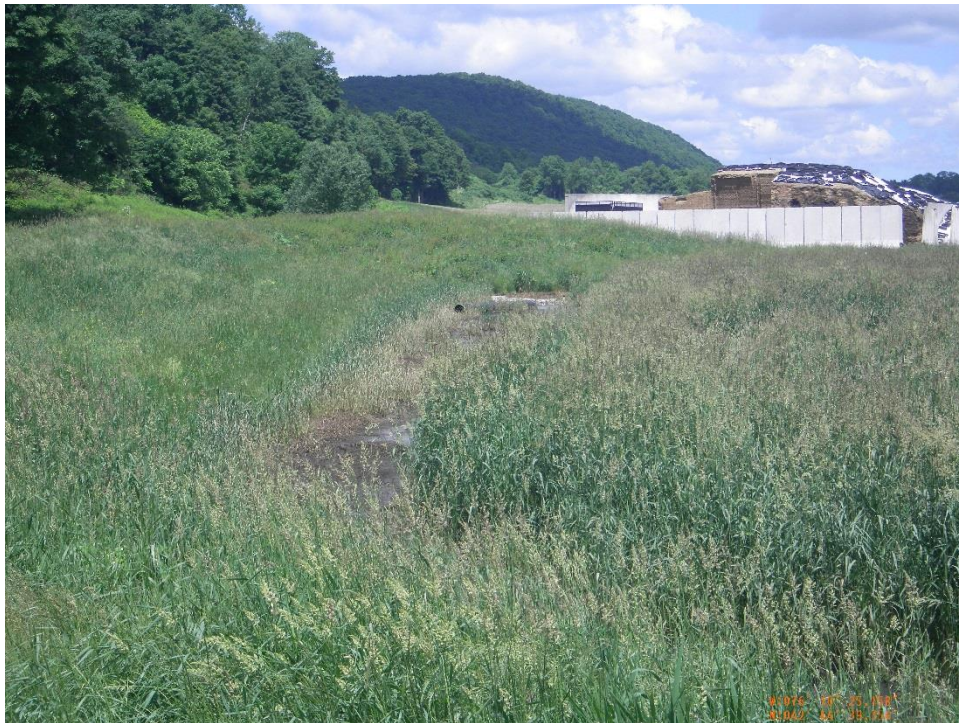
Photo #12 – Channelized flow from underbunk drainage collection system toward the on-site farm pond; view looking north

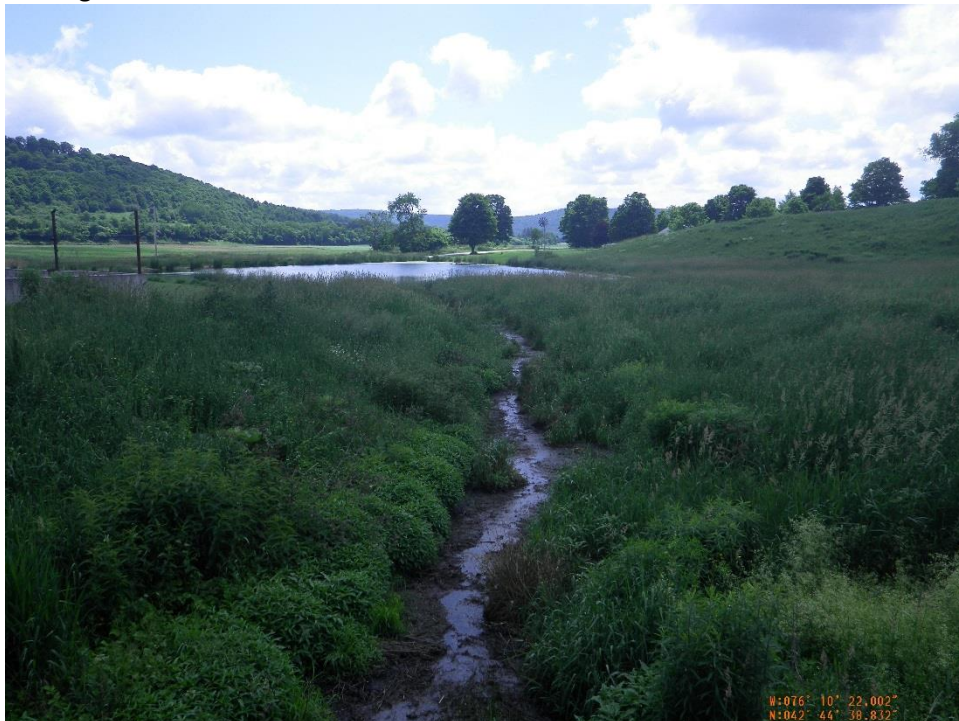
Photo #13 – Flow from underbunk drainage collection system (photos 11 & 12) toward on-site farm pond; view looking south

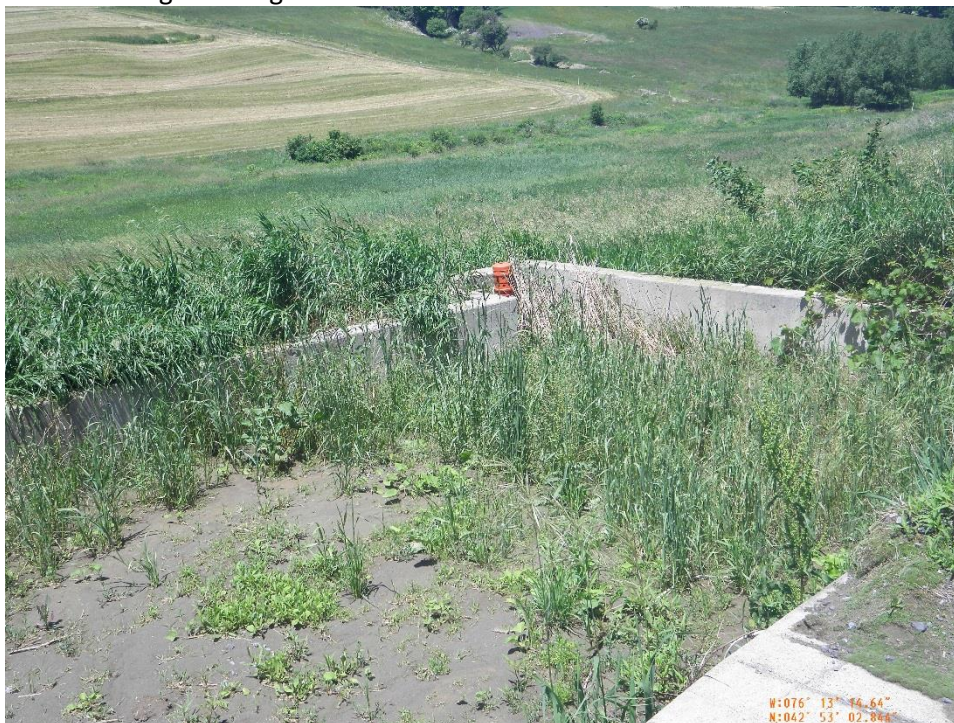
- Overgrown vegetation in the VTA

Photo #14 – Overgrown vegetation in VTA; view looking from collection system at Cell #3 (not in use) toward Cells #1 & 2

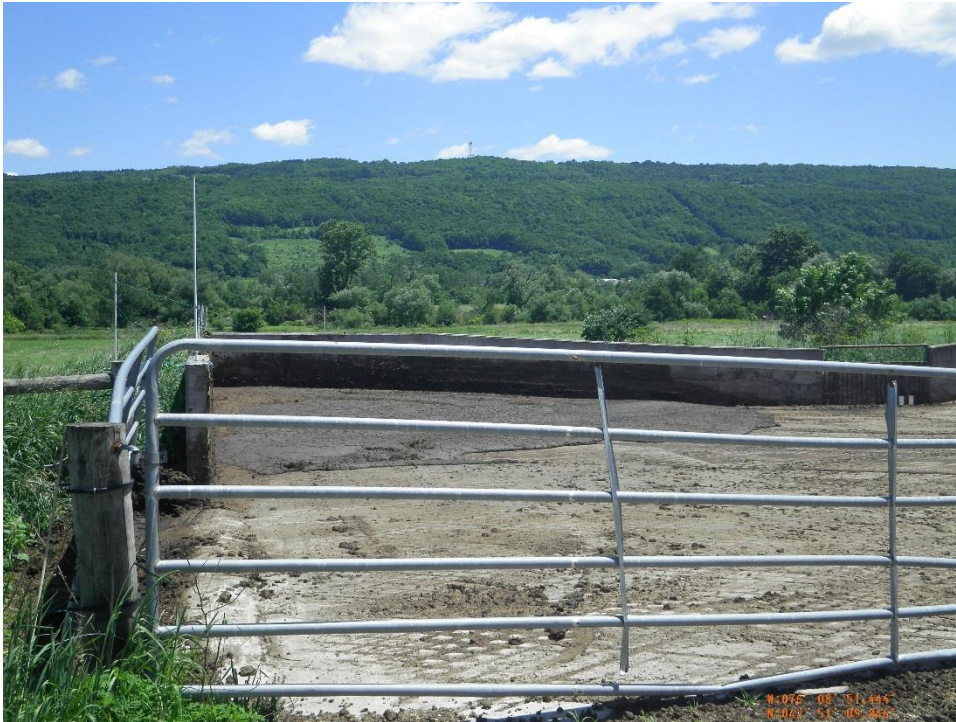
Photo #15 – North barnyard/manure stacking area at Kuss' Farm; view looking east

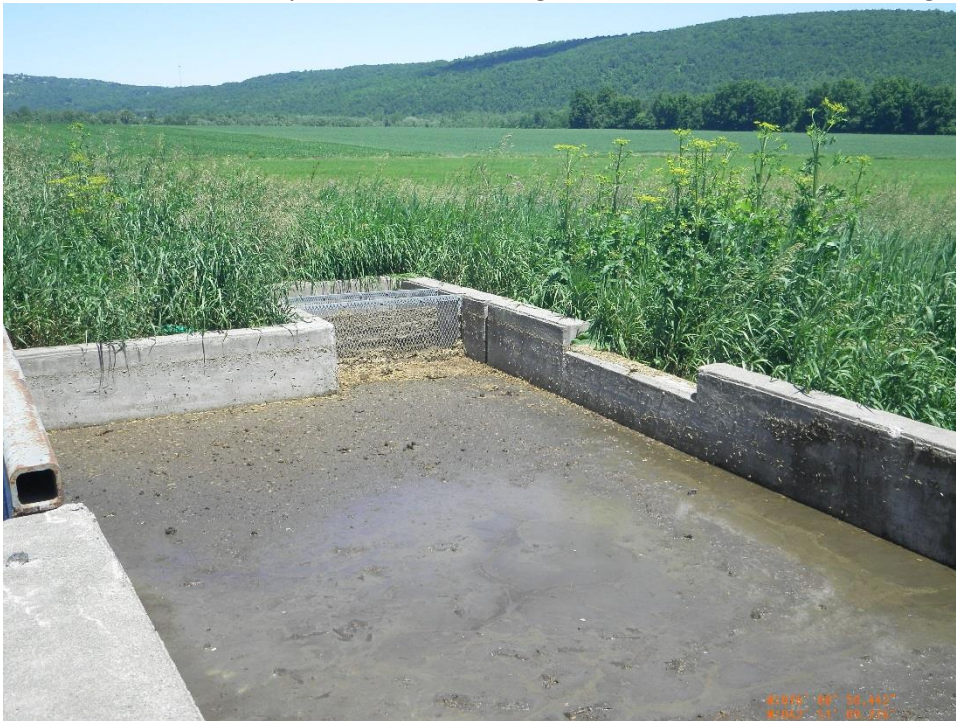
During the inspection, EPA Inspector Arvizu observed that the screens in the collection system were clogged with residue feed and solids. Mr. Vogel stated that the screens are usually cleaned 5 to 6 times a year, but could not definitively recall when the screens were last cleaned as there was no set schedule for cleaning.

Photo #16 – North barnyard collection system at Kuss' Farm; note buildup of feed and residue in screens
